How to Prevent the Five Most Common Air and Water-Resistive Barrier Transition Failures

Many building envelope issues don't start with the air and water-resistive barrier (AWRB) product itself, they start at the transitions between building materials or systems.

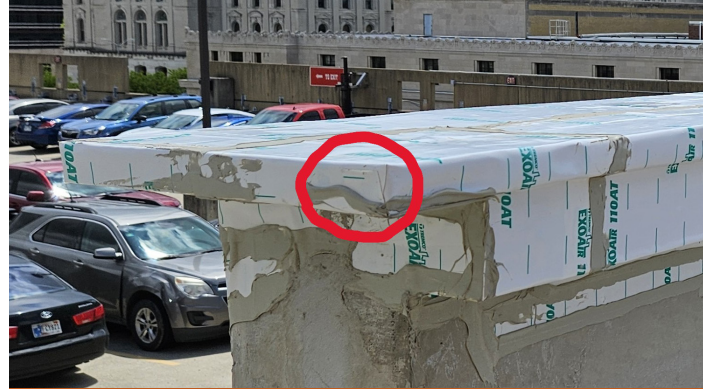
A reverse lap condition like the one circled here with an upward-facing overlap creates a direct pathway for water intrusion and can defeat the intended drainage plane.

When an upper layer of building material is tucked under instead of overlapping properly, this mistake is referred to as reverse shingling. Water will move behind the barrier instead of shedding outward.

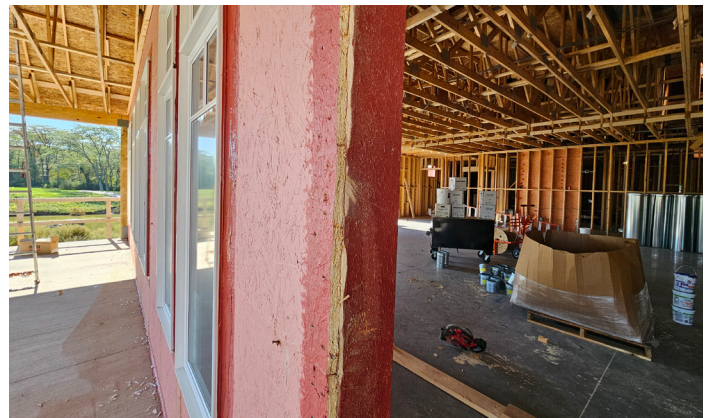
If left this way, there will be air leaks at this interface where the rough opening prep is not integrated with the exterior wall air barrier. When properly prepped, the pink fluid-applied air and water-resistive barrier on the left meets the red liquid flashing on the right, and fully covers the transition between sheathing and 2x4 framing that's visible in this image.

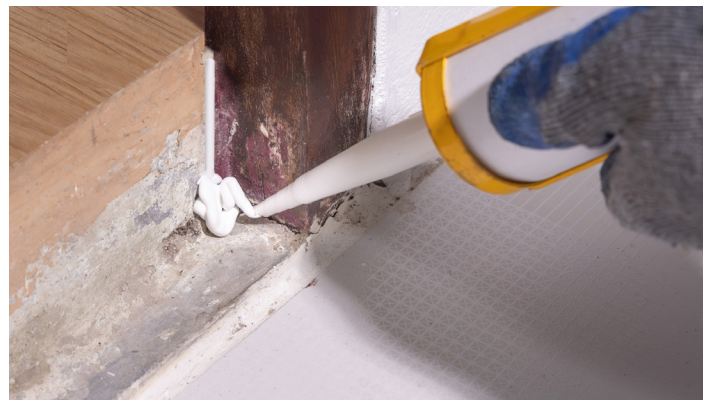
Excess sealant is not a viable substitute for a properly detailed AWRB system.

Sealant is important, but it's not the system. Sealant is a component that must be backed up by proper detailing and continuity.

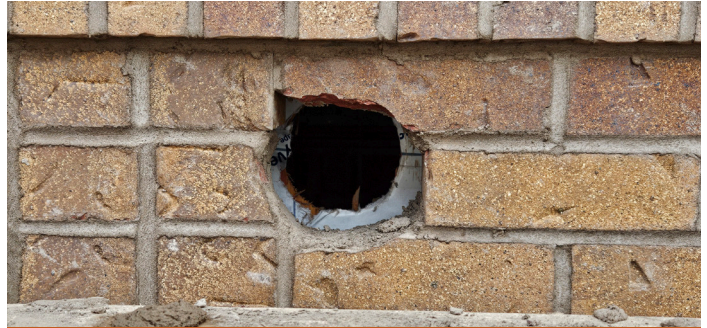
This condition resulted from inadequate coordination of work sequencing. The mechanical penetration was installed after the AWRB and subsequently concealed by masonry cladding, eliminating access to properly install flashing and achieve continuous air and water barrier integration at the mechanical sleeve.

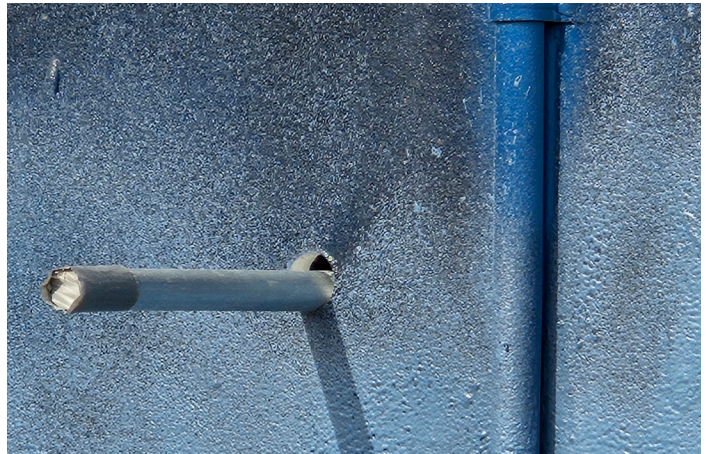
This unsealed penetration through the AWRB was a result of a scope gap at trade handoff. Responsibility for flashing installation needs to be clearly scoped in bid documents.
